Chromates in the Workplace

Measurements and Analyses in the Handling of Contaminated Thermal Insulation – Chromates in the Workplace

by Lloyd Hopes, Markus Sommer and Florian Sommer

5 February 2025

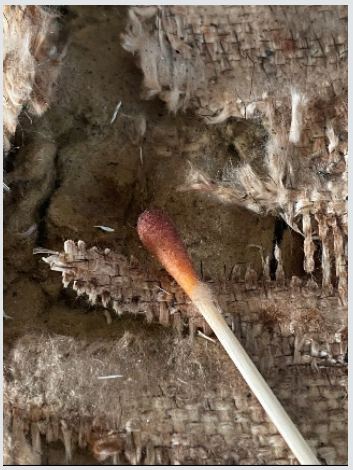
Fig.2 Storage

These findings underline the need for comprehensive protective measures even for seemingly non-critical activities such as interim storage (Fig. 2) or sorting of used insulation materials at the workplace. Insulation elements such as those shown in Fig. 3 are usually intended for further use, also because the contamination is not or only insufficiently known and is only indicated by a rapid test procedure.

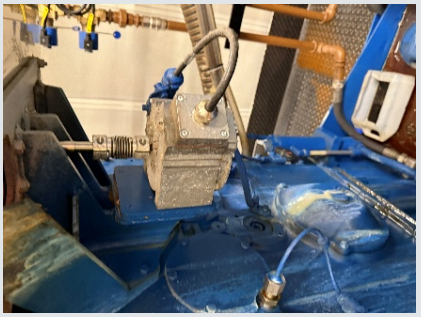
Fig.10 Fiber dust environment

Inadequate demarcations between contaminated and clean areas as well as inadequate decontamination processes lead to a steady expansion of contaminated zones.
