Chromates in the Workplace

Further observations on chromium(VI) formation by the use of alkali and/or alkaline earth metal containing insulation materials on chromium-containing metal hot parts on a gas engine

Supplementary observations to the Field Study – Chromates in the workplace

31 January 2025

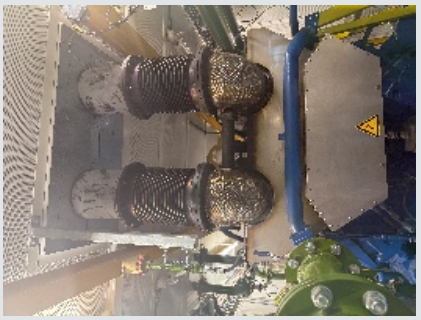
Fig.1 Insulation cassette

The observations show significant presence of carcinogenic and chronically environmentally harmful chromium(VI) compounds in areas of so-called "insulation cassettes" (Fig. 1), which consist of a chromium-containing housing, which includes insulation mats in the sandwich structure, and in some places, especially in bending and bending areas, includes "oxygen-open" areas (Fig. 2), on which fibers of the insulation mats are visible. These areas were tested **both according to the rapid test procedure "ST01"** and **tested positive for chromate presence with the test kit method "TK01" (Fig. 3).**

Fig.2 Bending areas

Fig. 3 Cr6-positive (TK01)

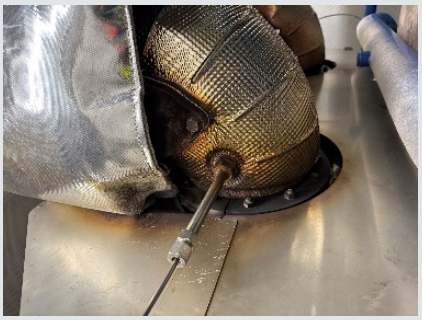
Fig.8 Insulation cassette, front

Fig.7 Insulation cassette, rear

Fig.9 Insulation cassette, inside

- Age of insulation: approx. 4500 operating hours
- The insulation cassettes were in a normal undamaged condition (Figs. 7 -9)
- Released insulating materials (see Field Study) also settled on the cassettes throughout the engine area, but due to the very precise geometries, no fiber penetration from the outside to the inside could be detected.

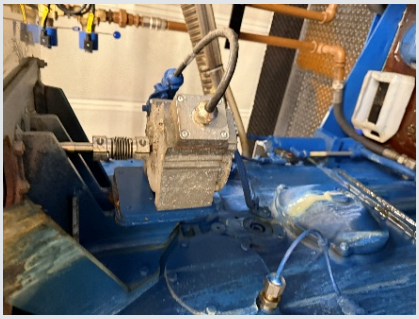
Fig.20 Fibre dust environment

The immediate working environment represents the main exposure area where the highest chromium(VI) concentrations occur in the form of background exposures due to mechanical processing and manipulation of the insulation cassettes.

The release takes place both through direct work processes and **through secondary whirling**, whereby **the handling of the cassettes in particular represent critical moments**.

Fig.21 Fiber dust environment

Fig.22 Fiber dust environment
